**UNITED STATES DEPARTMENT OF THE INTERIOR  
BUREAU OF SAFETY AND ENVIRONMENTAL ENFORCEMENT  
SUBMITTAL REPORT**

Operator: BP Exploration & Production Inc. (02481)  
 Business Process: Pipeline Permits and Reports  
 Submittal Type: Plan of Corrective Action  
 Project Name: Nakika  
 Submittal Coordinator: Shrestha, Bimal  
 Submittal Status: Approved  
 Submittal ID: 187447650  
 Status Date: 17-DEC-2020  
 Submittal Description: Na Kika Galapagos Loop Revised Corrective Action  
 Remarks: bp was able to locate the point of ingress/egress in the same segment using the corrective action plan (CA83P) approved on November 2, 2020 as given in detail in Section 3 of the attached plan.

Reference: 2020 Plan of Corrective Action - Revised  
Segment No. 16283

## Revision 3 of Galapagos LSPS Response Corrective Action Plan

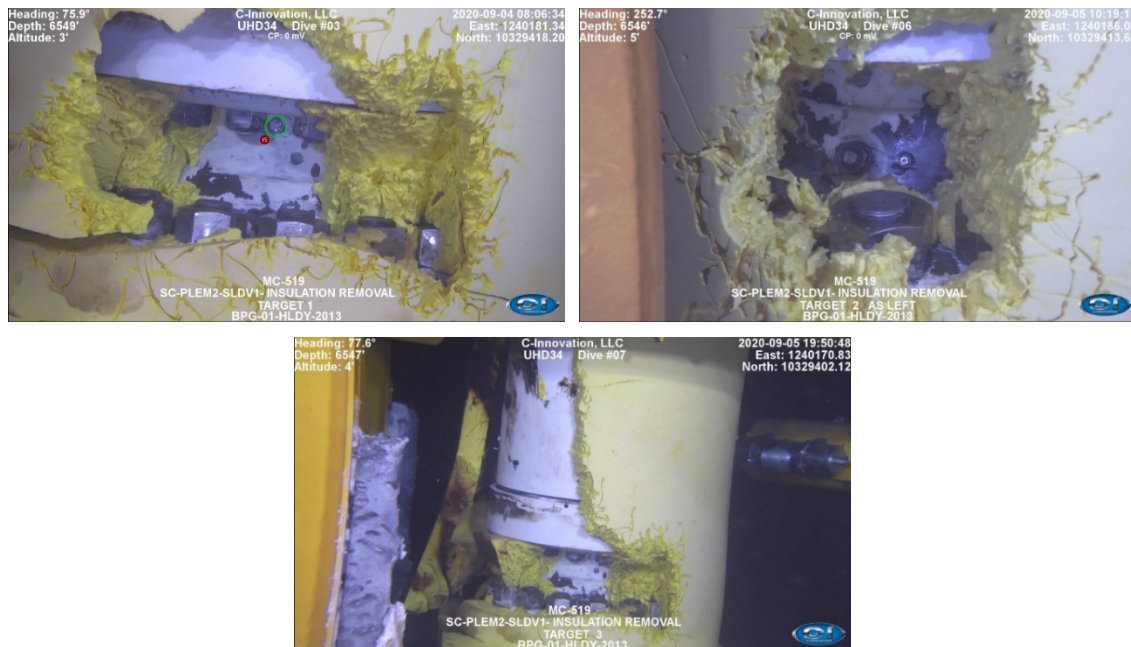
*Figure 2: Insulation Removal Results for Grease Port and Disbonded Insulation (Targets 1-3)*

**3 - 5 September 2020** – Insulation was removed (Figure 2) at grease port locations and other areas where it had disbonded on the SLDV1 valve located at the SC PLEM2. While the insulation removal campaign was unable to identify the leak source, results indicated that additional insulation removal would increase the probability of determining the leak source.

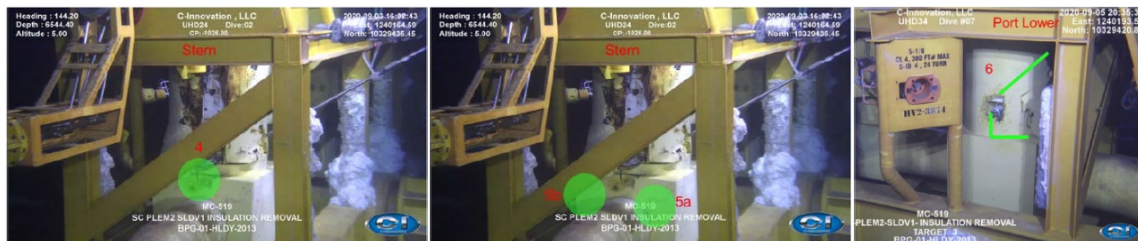
*Figure 3: Additional Insulation Removal Targets (Targets 4-6)*

**25 - 29 September 2020** – Following approval of previous Corrective Action Plan on 14 September 2020, additional insulation was removed (Figures 3 – 5) as attempts to pressurize the SC PLEM2 failed due to lack of communication to the bore.

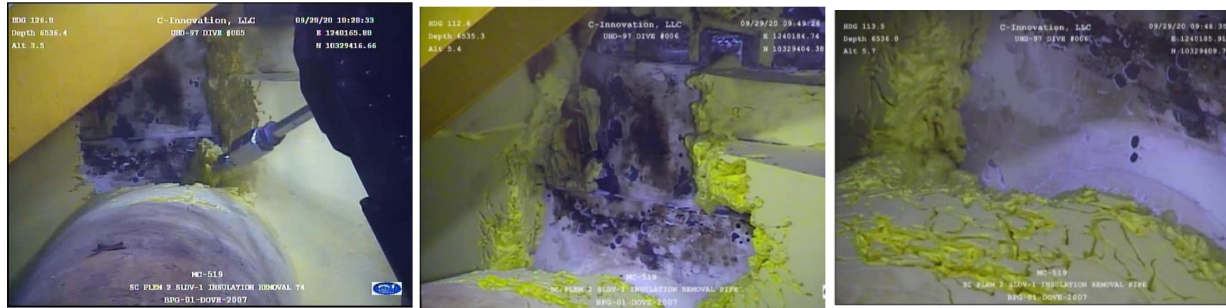
Figure 4: Insulation Removal Results for Targets 4, 5a and 5b

While additional insulation removal was unable to identify the leak source, visibility at the areas of interest (targets) had been improved and the likelihood of finding the leak source during pressurization has increased.

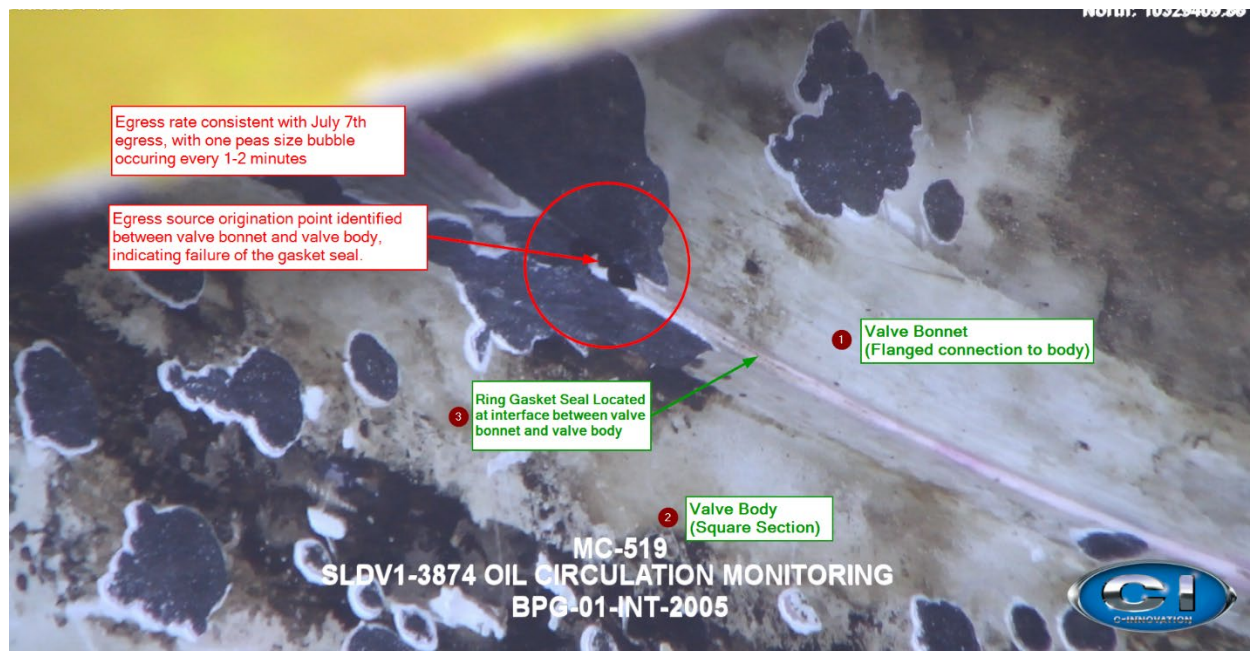
Figure 6: Egress Location

**10 – 16 November 2020:** When dead oil circulation was initiated, ROV observed dead oil or other fluid egress from the SLDV1 valve located at SC PLEM 2. The egress source origination point was identified as the gasket seal located between the valve bonnet and valve body; see Figure 6. ROV was utilized to collect the egressed volume located under the containment dome and the collected sample bottle returns were sent to Core Labs for testing. No additional egress points were identified during the circulation test.

Egress was witnessed at 14:40 on 15 November following roughly 36 hours of circulation. The egress rate was estimated to be a single pea size bubble ( $1 \text{ cm}^3$ ) releasing at an interval of 1 to 2 minutes. The last witnessed release was at 04:23 on 16 November, with the pressure in the SC2 PLEM returning to below hydrostatic conditions at roughly 5:15. The volume of the release is therefore estimated to be between  $411 \text{ cm}^3$  (.10 gal) and  $875 \text{ cm}^3$  (.23 gallons). No additional bubbles were observed after the pressure was returned to below hydrostatic conditions.

Based on findings of the 10 – 16 November 2020 campaign, BP is proposing the following Corrective Action Plan to mitigate the SC2 PLEM egress from the SLDV1 valve gasket seal located at the interface of the valve bonnet and body.

1. Install containment dome above SC PLEM2 SLDV1.
2. Re-torque the actuator flange bolts on SC PLEM 2 SLDV1 per Original Equipment Manufacturer (OEM) recommendation.
3. Perform an ingress test to confirm integrity (no increase in pressure in the SA flowline).
4. Perform a leak test to 1.1 times maximum allowable operating pressure (MAOP) with dead oil (currently in the flowline) to confirm integrity of the system with no unexplained pressure behaviors and no ROV-observed egress.
5. Perform hot oil circulation and achieve a temperature of 120F or higher at SC PLEM2. Confirm no temperature related egress.
